# Stakeholder Driven Remediation

The Maralinga Rehabilitation Project Case Study

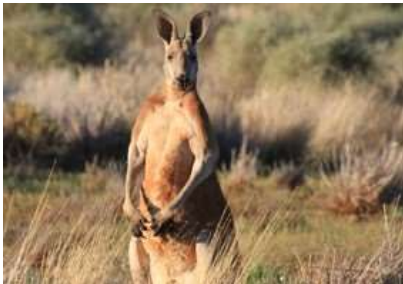
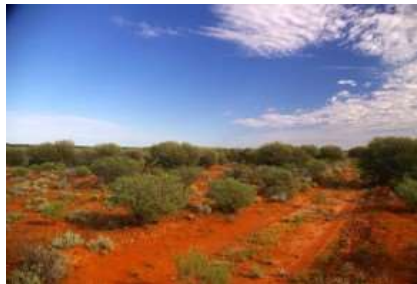
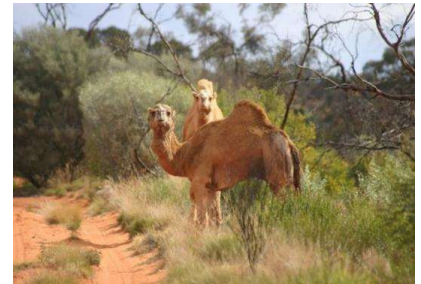
- Determine the nature of the hazard - external dose, inhalation, particles.
- Characterise the contamination through field & laboratory studies – particle size distribution, dust loadings, radionuclides present, solubilities and chemical properties.
- Effects on the environment - uptake by plants & animals.
- Spatial extent of the contamination - aerial and ground-based surveys.

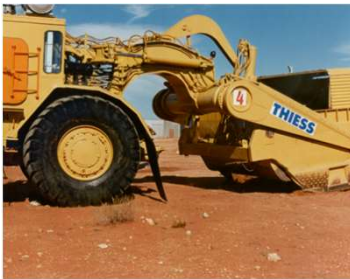
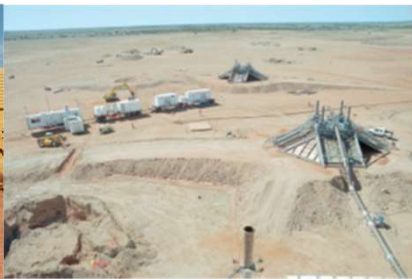
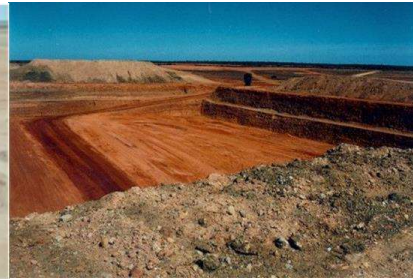
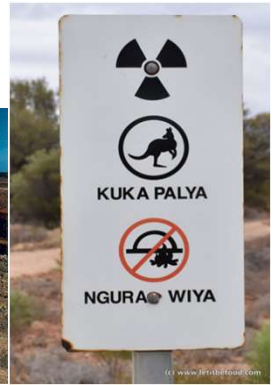
Industrial-scale land clearing of contaminated soil – 2.5 km<sup>2</sup>

In Situ Vitrification of historic disposal pits

Burial of contaminated material on site - 5 trenches ~ 400,000 m<sup>3</sup>

In Situ Vitrification encountered safety issues and was abandoned as a methodology during the project.

Largest burial trench contains 250,000 m<sup>3</sup> of soil and 3 kg of Pu

All contaminated soil is at least 5 m below surface.

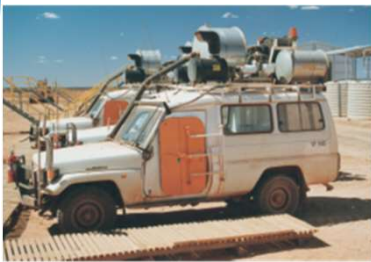
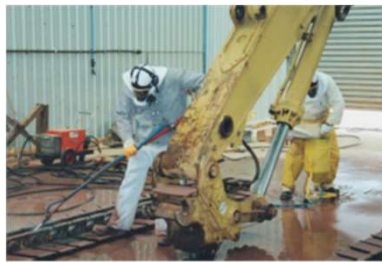
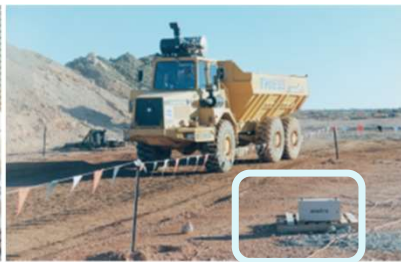
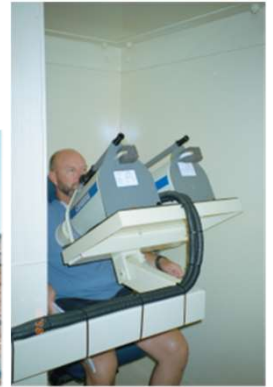
The plant used for this operation were specially modified standard machines.

Modifications included:

- strengthening and sealing of cabins;
- fitting of 'submarine' doors;
- high strength glazing;
- high efficiency particulate air (HEPA) filtering cabin and engine inlets; and
- stripping plant of unnecessary fittings.

The cabins operated at a continuous over-pressure and had warning alarms that activated if the cabin over-pressure dropped. The modified plant allowed most fieldwork to be conducted in a clean environment free of any requirement for personal protective equipment. This had two advantages:
